Site Inspection Summary

Surf Life Saving New Zealand

Whiritoa | Kon Tiki Road, Whiritoa Beach,
Whiritoa

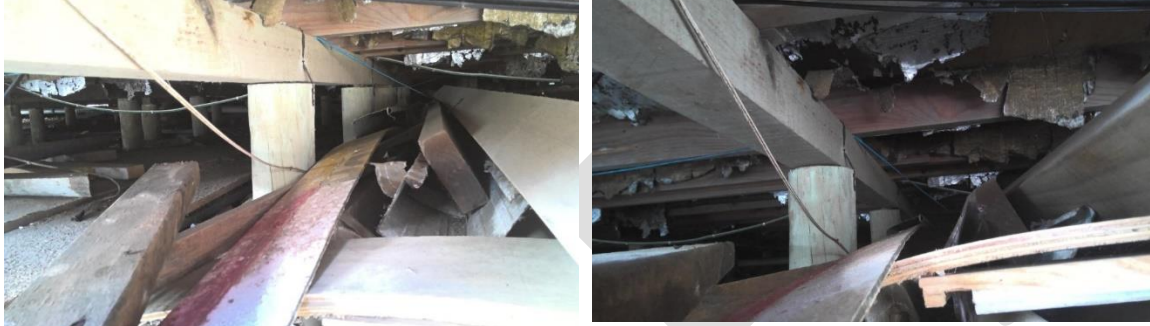
Foundations		
Material:	General Condition:	Actions Required:
Timber piles and concrete	Poor condition	Initial Seismic Assessment (ISA) to ensure the building meets an acceptable seismic standard. This would not be required if intent is for new facility to be constructed.
Photos:

Rating: ●

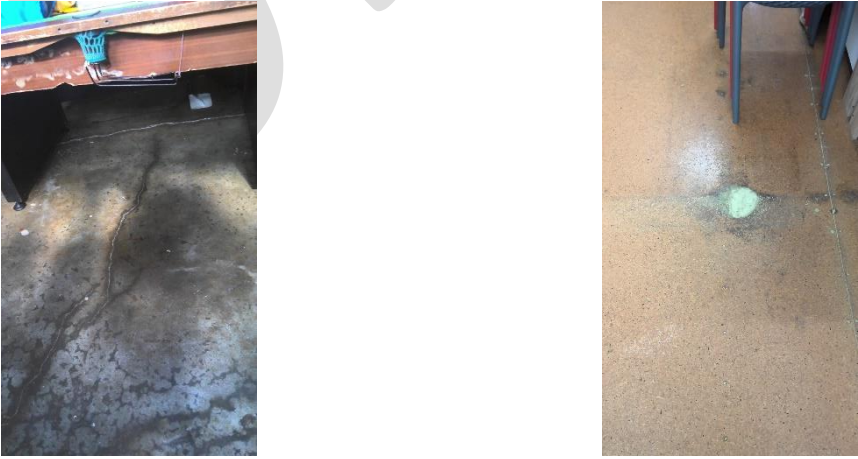
Floors		
Material:	General Condition:	Actions Required:
Mix Timber and concrete	Average. Timber piles cause issues with timber floor. Cracks in concrete floor.	Initial Seismic Assessment (ISA) to ensure the building meets an acceptable seismic standard. This would not be required if intent is for new facility to be constructed.
Photos:

Rating: ●

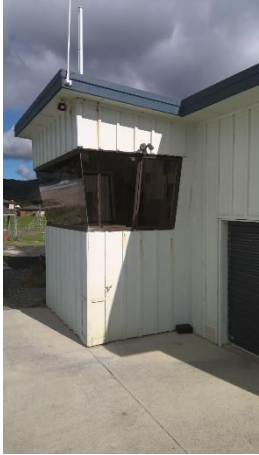
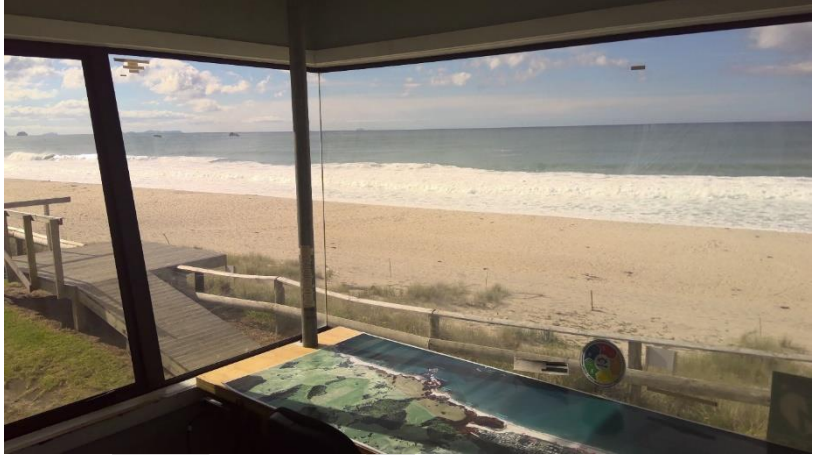
Tower (Beach Observation)		
Material:	General Condition:	Actions Required:
Part of storage area of main building	Poor condition. Leaks apparent.	Replace tower.
<p>Photos:</p> <div style="display: flex; justify-content: space-around;">

</div>		
<p>Rating: ●</p>

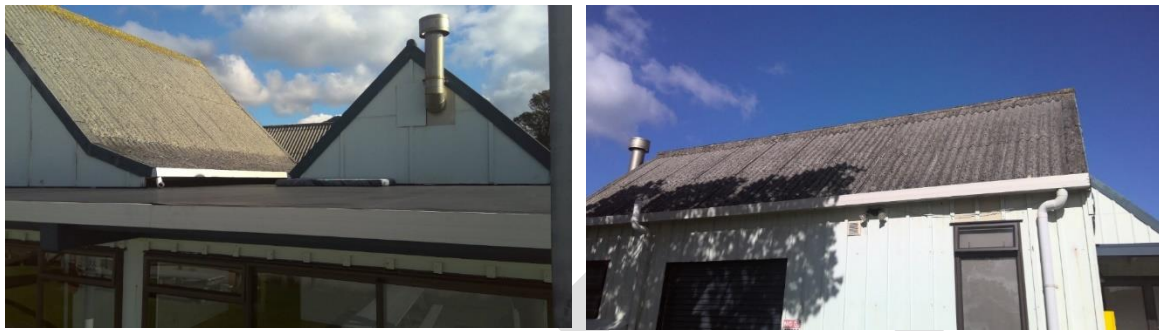
Roof		
Material:	General Condition:	Actions Required:
Mix super 6 and butanol.	Poor condition. Asbestos and leaking.	Replace roof
Photos:

Rating: ●

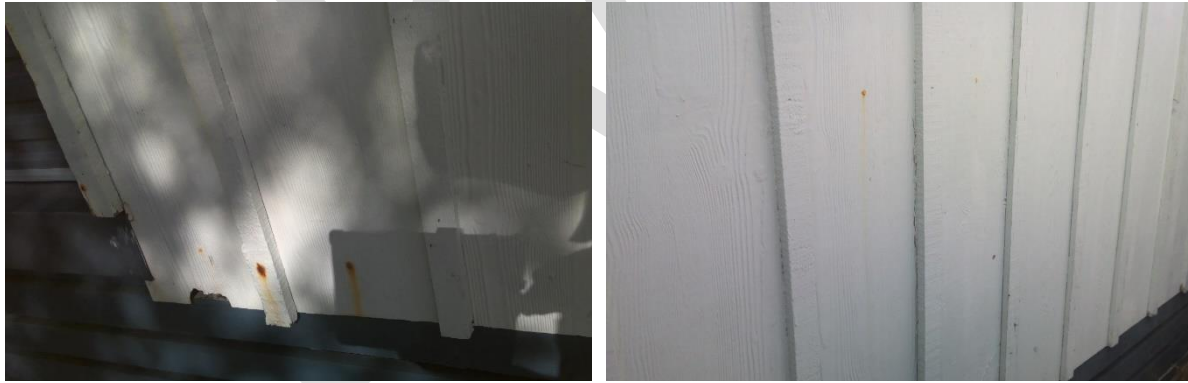
External Cladding		
Material:	General Condition:	Actions Required:
Fibre board and timber batten.	Poor condition. Nails rusting through. Likely asbestos	Replace cladding
Photos:

Rating: ●

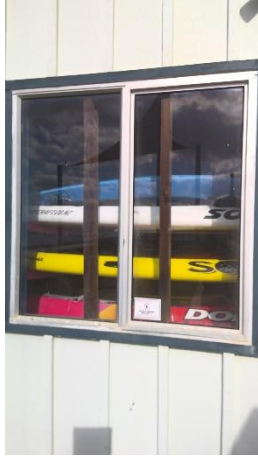
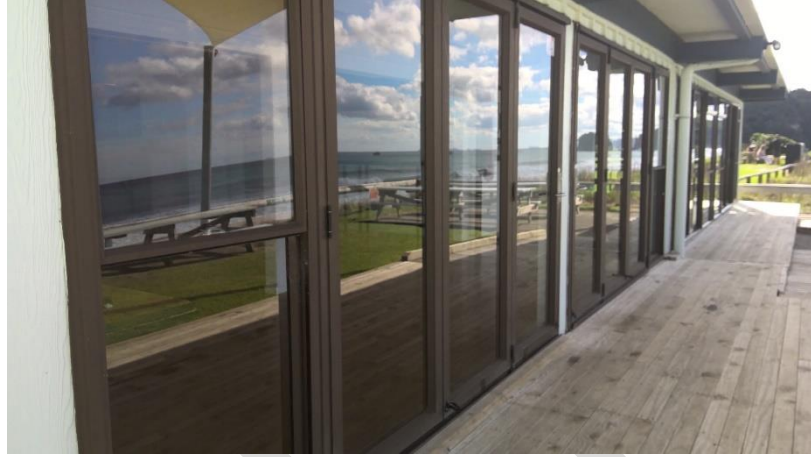
Window Joinery/Glazing

Material:	General Condition:	Actions Required:
Aluminium and single	Fair condition	Requires monitoring

Rating: ●

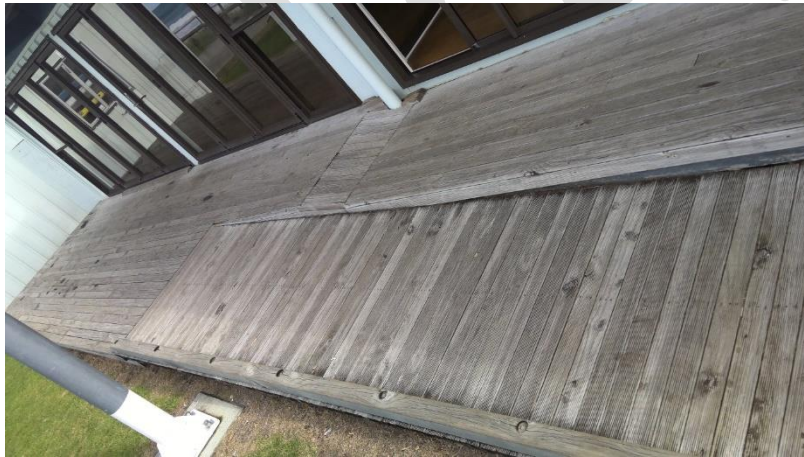
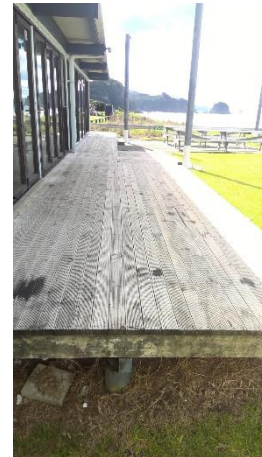
Deck

Material:	General Condition:	Actions Required:
Timber	Fair condition	Requires monitoring

Rating: ●

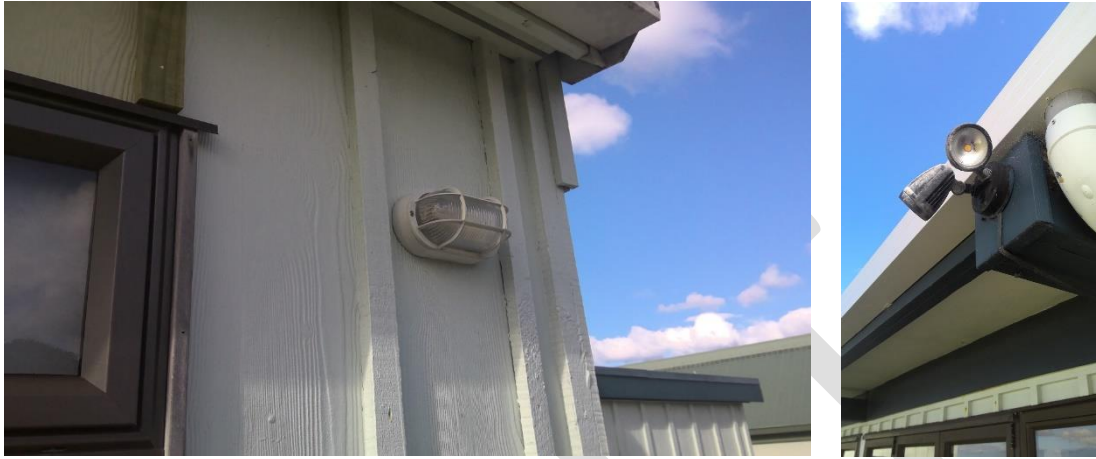
Lighting		
Material:	General Condition:	Actions Required:
Standard	Fair condition	Requires monitoring
Photos:

Rating: ●

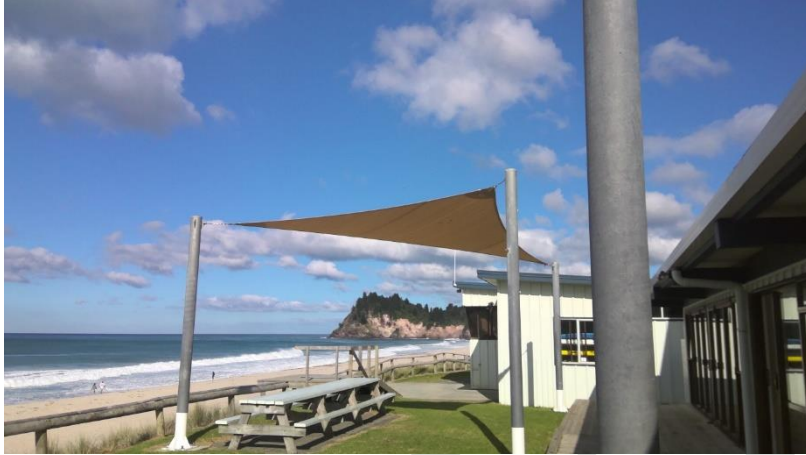
Shade Areas

Material:	General Condition:	Actions Required:
Shade sails	Fair condition. (one sail ripped at time of inspection).	Requires monitoring

Rating: ●

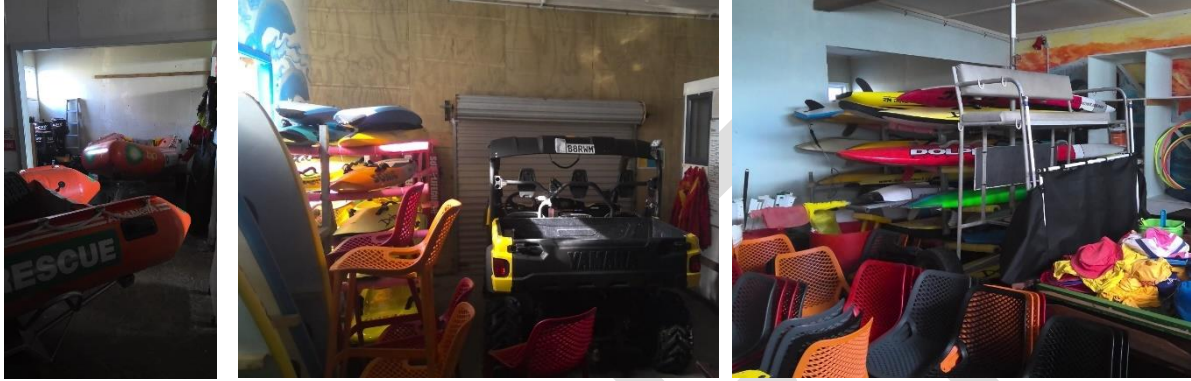
Storage Areas		
Material:	General Condition:	Actions Required:
Part of main building	Average condition (some leaks). Not fit for purpose – too small.	Construct extra storage
Photos:

Rating: ●

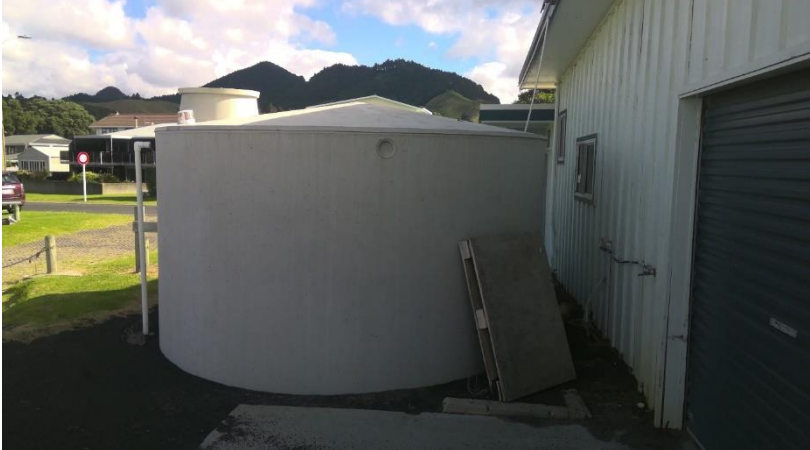
Water Supply/Storage		
Material:	General Condition:	Actions Required:
Bore into tank	Fair condition	Requires monitoring
Photos:

Rating: ●

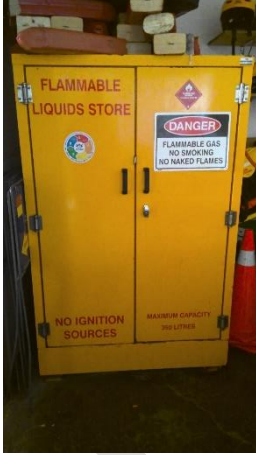
Hazardous Goods (Fuel) Storage		
Material:	General Condition:	Actions Required:
Steel fuel cabinet	Fair condition	Requires monitoring
Photos: <div style="text-align: center;">

</div>		
Rating: ●

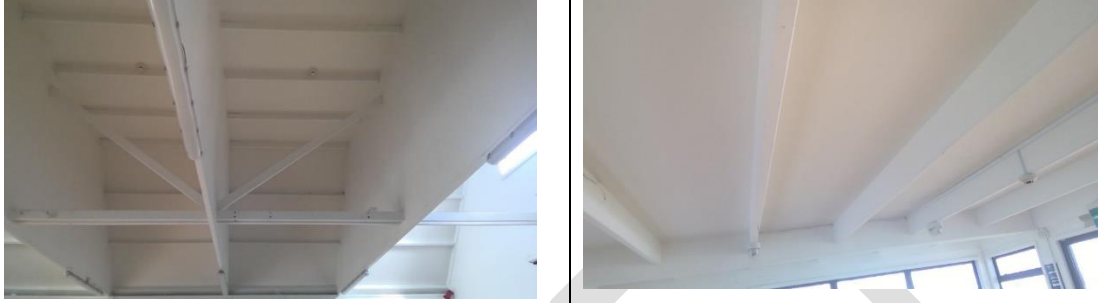
Ceiling		
Material:	General Condition:	Actions Required:
Exposed painted timber ceiling	Fair condition	Requires monitoring
Photos:

Rating: ●

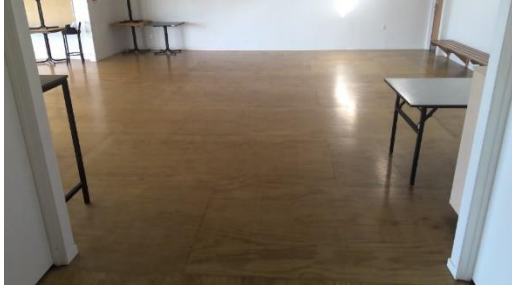
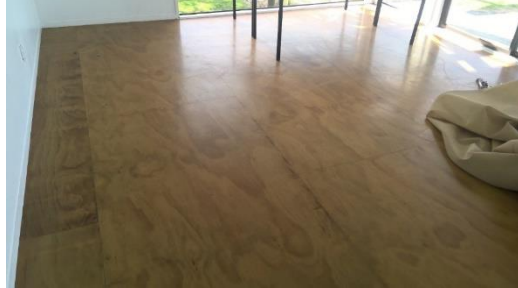
Floors

Material:	General Condition:	Actions Required:
Plywood	Fair condition	Requires monitoring

Rating: ●

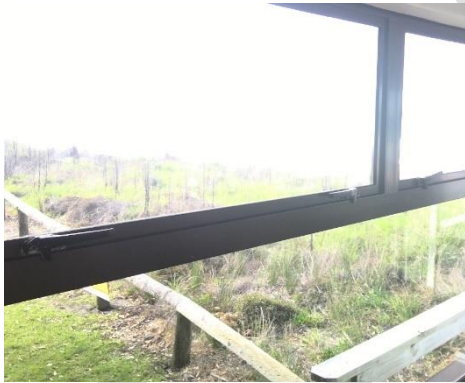
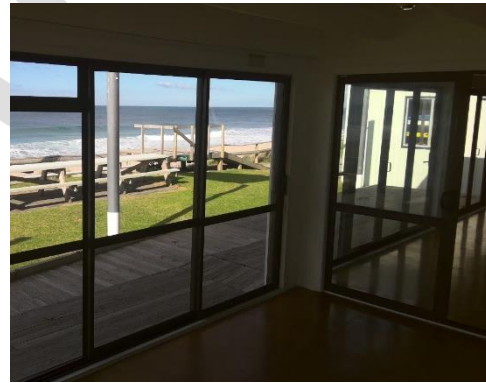
Windows & Window Sills

Material:	General Condition:	Actions Required:
Aluminium and timber	Fair condition	Requires monitoring

Rating: ●

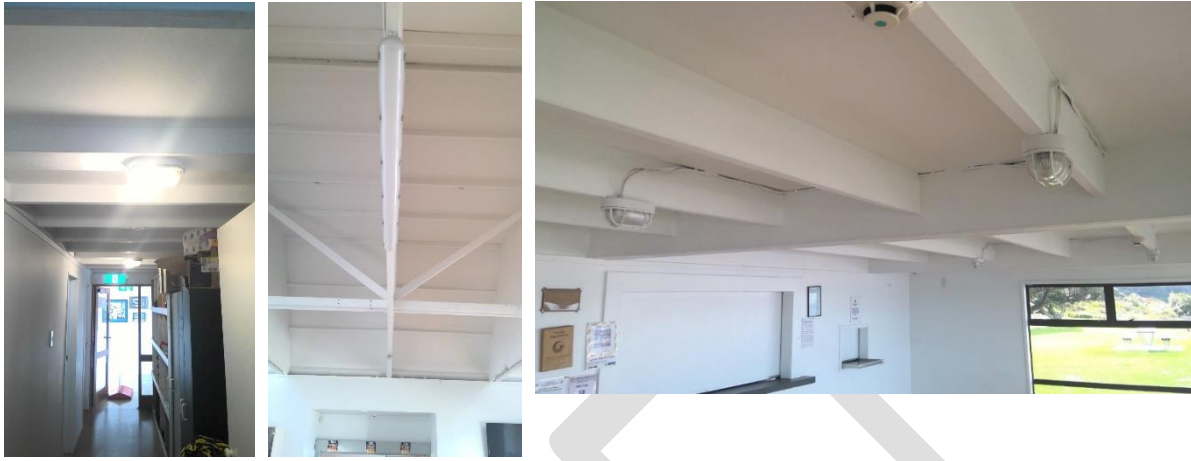
Lights		
Material:	General Condition:	Actions Required:
Standard	Fair condition	Requires monitoring
Photos:

Rating: ●

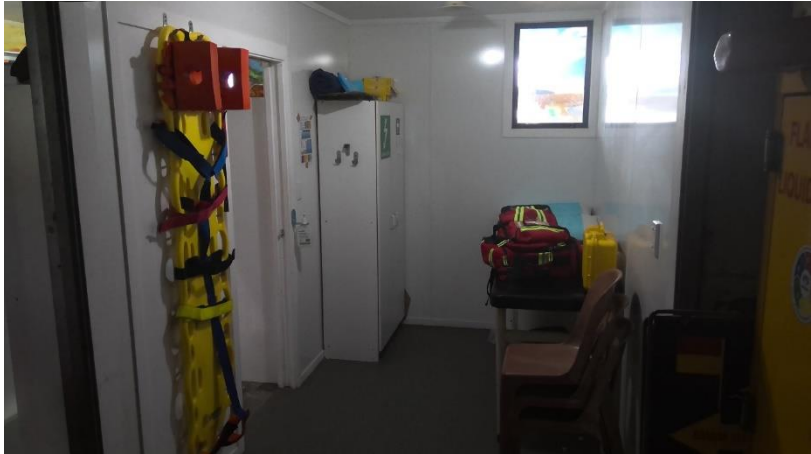
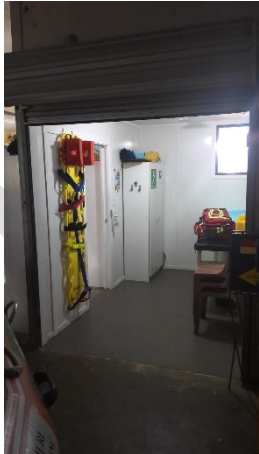
First Aid		
Material:	General Condition:	Actions Required:
Sectioned off area as part of garage/storage area.	Average condition. Not fit for purpose – too small.	Replace first aid room
<p>Photos:</p> <div style="display: flex; justify-content: space-around;">

</div>		
<p>Rating: ●</p>

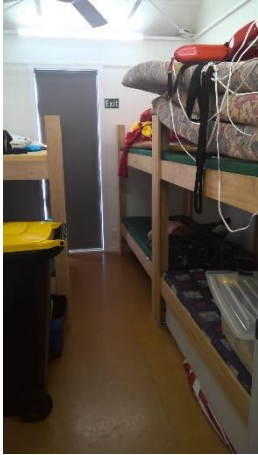
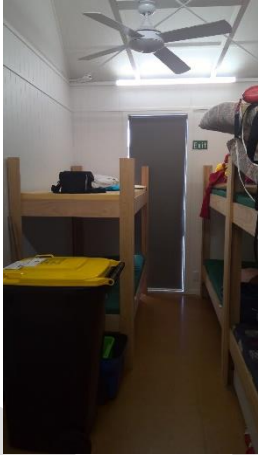
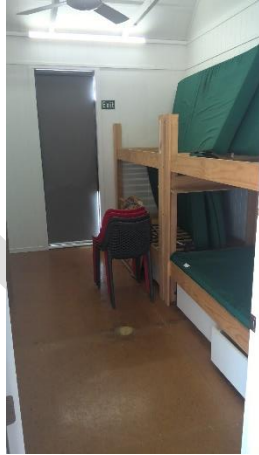
Bunk Rooms		
Material:	General Condition:	Actions Required:
Two separate rooms as part of main building.	Fair condition but not fit for purpose as too small.	Construct additional bunk rooms.
Photos: <div style="display: flex; justify-content: space-around; align-items: flex-start;">

</div>		
Rating: ●

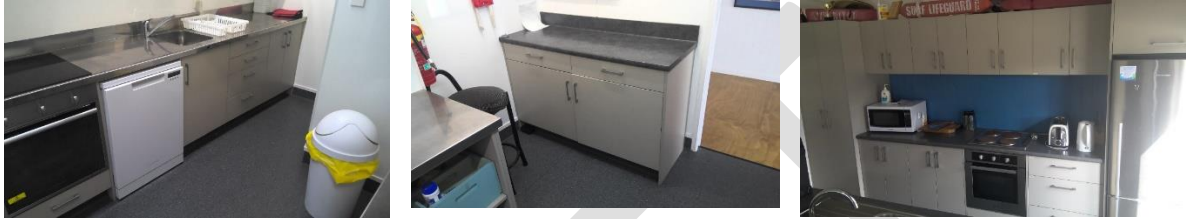
Cabinetry		
Material:	General Condition:	Actions Required:
MDF	Good	No actions required
Photos:

Rating: ●

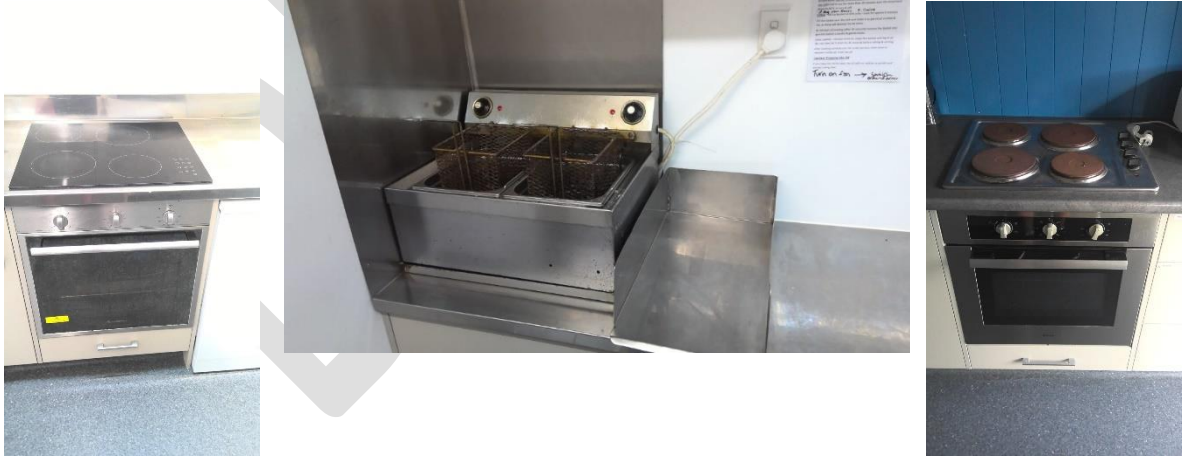
Oven		
Material:	General Condition:	Actions Required:
Standard ovens and hobs. Commercial deep fryer.	Fair condition	Requires monitoring
Photos:

Rating: ●

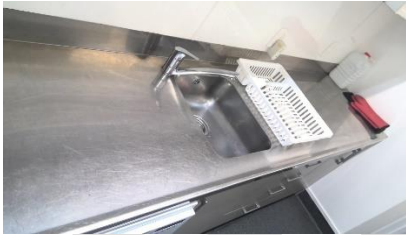
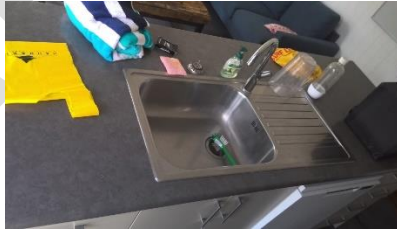
Sink, Taps, Bench etc.		
Material:	General Condition:	Actions Required:
Stainless and MDF	Good	No actions required
Photos: <div style="display: flex; justify-content: space-around;">

</div>		
Rating: ●

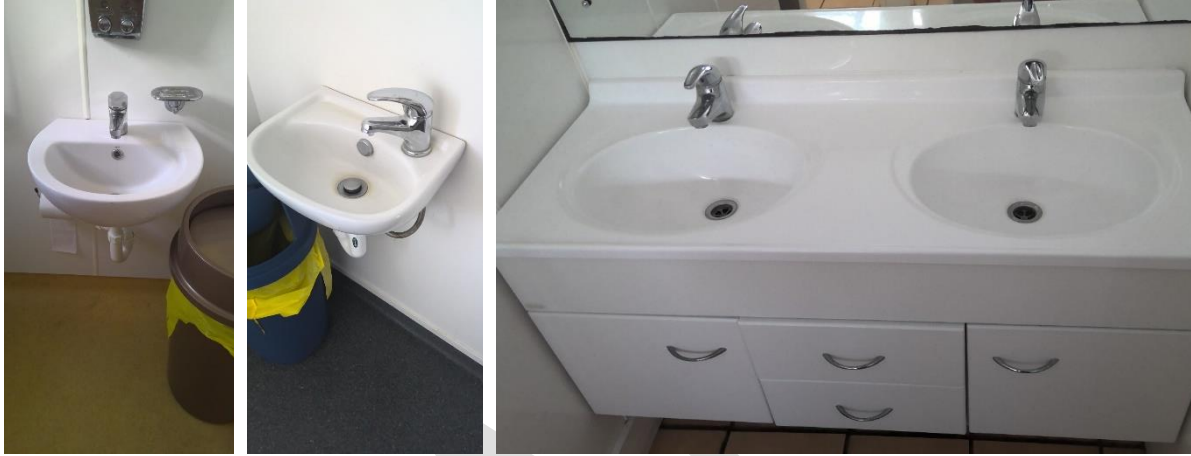
Vanity/Basin & Taps		
Material:	General Condition:	Actions Required:
Mix ceramic and plastic.	Good condition	No actions required
Photos:

Rating: ●

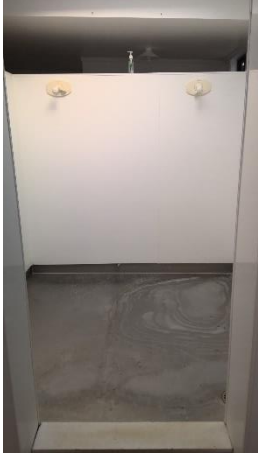
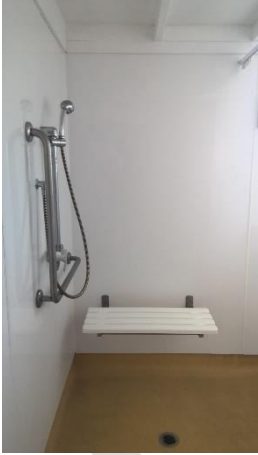
Showers		
Material:	General Condition:	Actions Required:
Lined showers	Fair condition	Requires monitoring
Photos:

Rating: ●

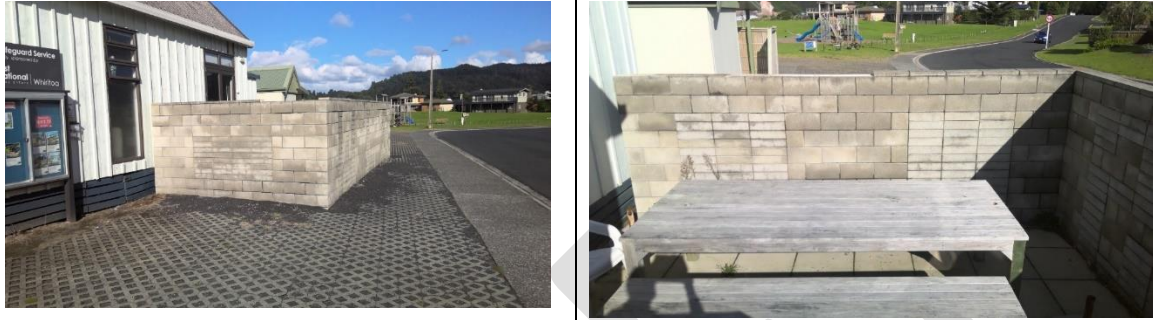
Fences/Gates		
Material:	General Condition:	Actions Required:
Concrete block fence as part of lifeguard club area.	Good condition.	No actions required
Photos:

Rating: ●

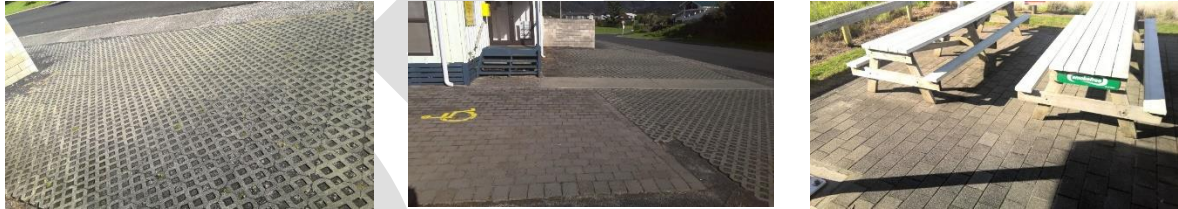
Sealed Areas (Driveways/Parking/Paths)		
Material:	General Condition:	Actions Required:
Cobbled parking and footpaths.	Fair condition	Requires monitoring
Photos:

Rating: ●

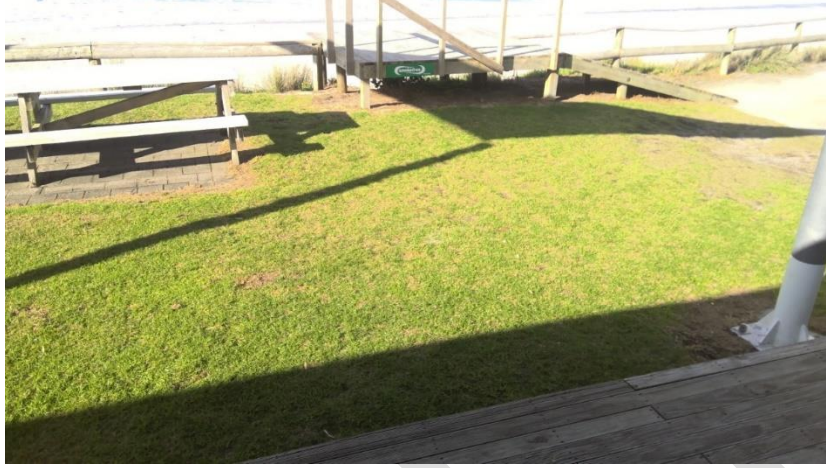
Landscaping

Material:	General Condition:	Actions Required:
Grassed area at front of club	Fair condition	Requires monitoring

Rating: ●

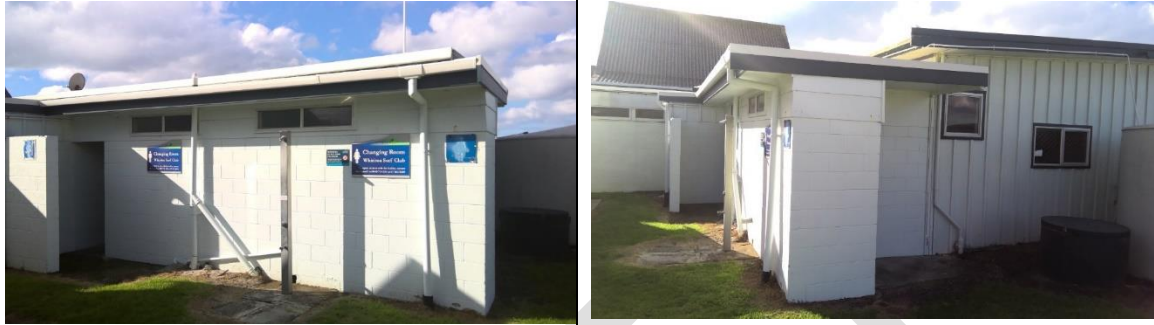
Public Facilities		
Material:	General Condition:	Actions Required:
Public changing rooms	Fair condition – Council responsible	Requires monitoring
Photos:

Rating: ●
