WHIRITOA LIFEGUARD SERVICE CLUBHOUSE COMMUNITY PRESENTATION

VEROS REPORT - AUG 2021

Veros undertook a nationwide assessment, on **behalf of Surf Life Saving New Zealand (SLSNZ)**, of all existing club facilities with an intent to develop a long-term facilities management plan.

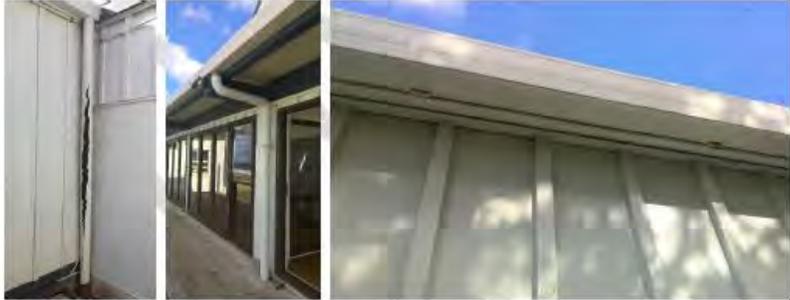
Gutters/Spouting		
Material:	General Condition:	Actions Required:
Mix colour steel and PVC	Poor condition	Replace gutters
Photos:

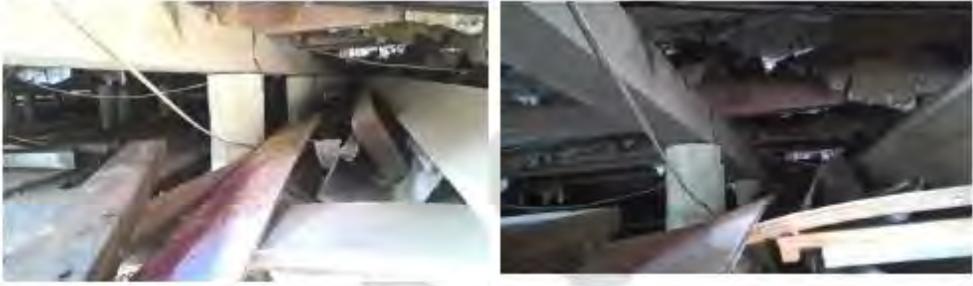
Foundations		
Material:	General Condition:	Actions Required:
Timber piles and concrete	Poor condition	Initial Seismic Assessment (ISA) to ensure the building meets an acceptable seismic standard. This would not be required if intent is for new facility to be constructed.
Photos:

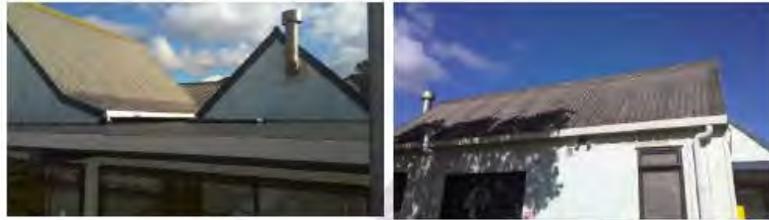
Roof		
Material:	General Condition:	Actions Required:
Mix super 6 and butanol.	Poor condition. Asbestos and leaking.	Replace roof
Photos:

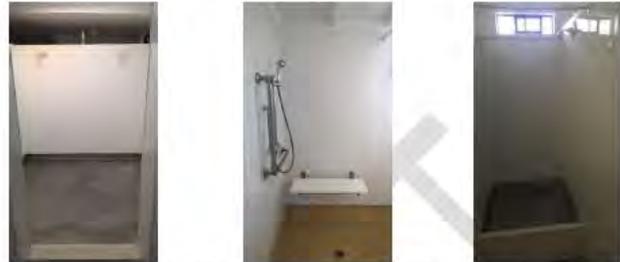
Showers		
Material:	General Condition:	Actions Required:
Lined showers	Fair condition	Requires monitoring
Photos:

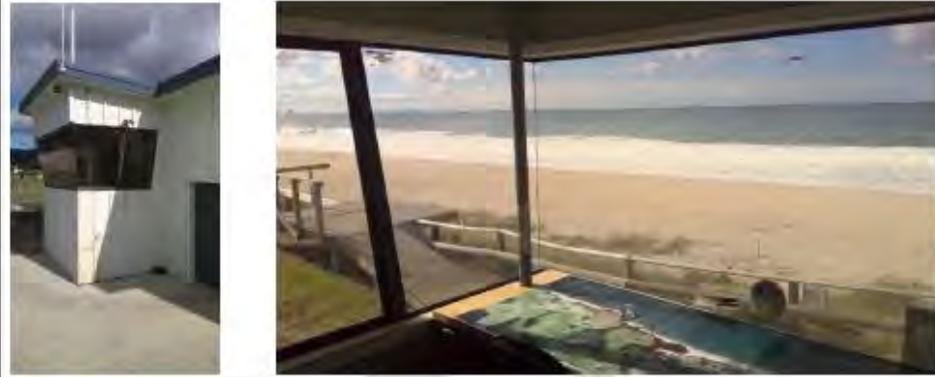
Tower (Beach Observation)		
Material:	General Condition:	Actions Required:
Part of storage area of main building	Poor condition. Leaks apparent.	Replace tower.
Photos:

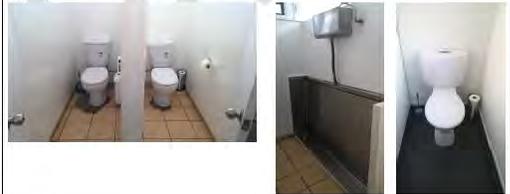
Toilets		
Material:	General Condition:	Actions Required:
Standard	Good condition. Urinal average condition.	Requires monitoring
Photos:

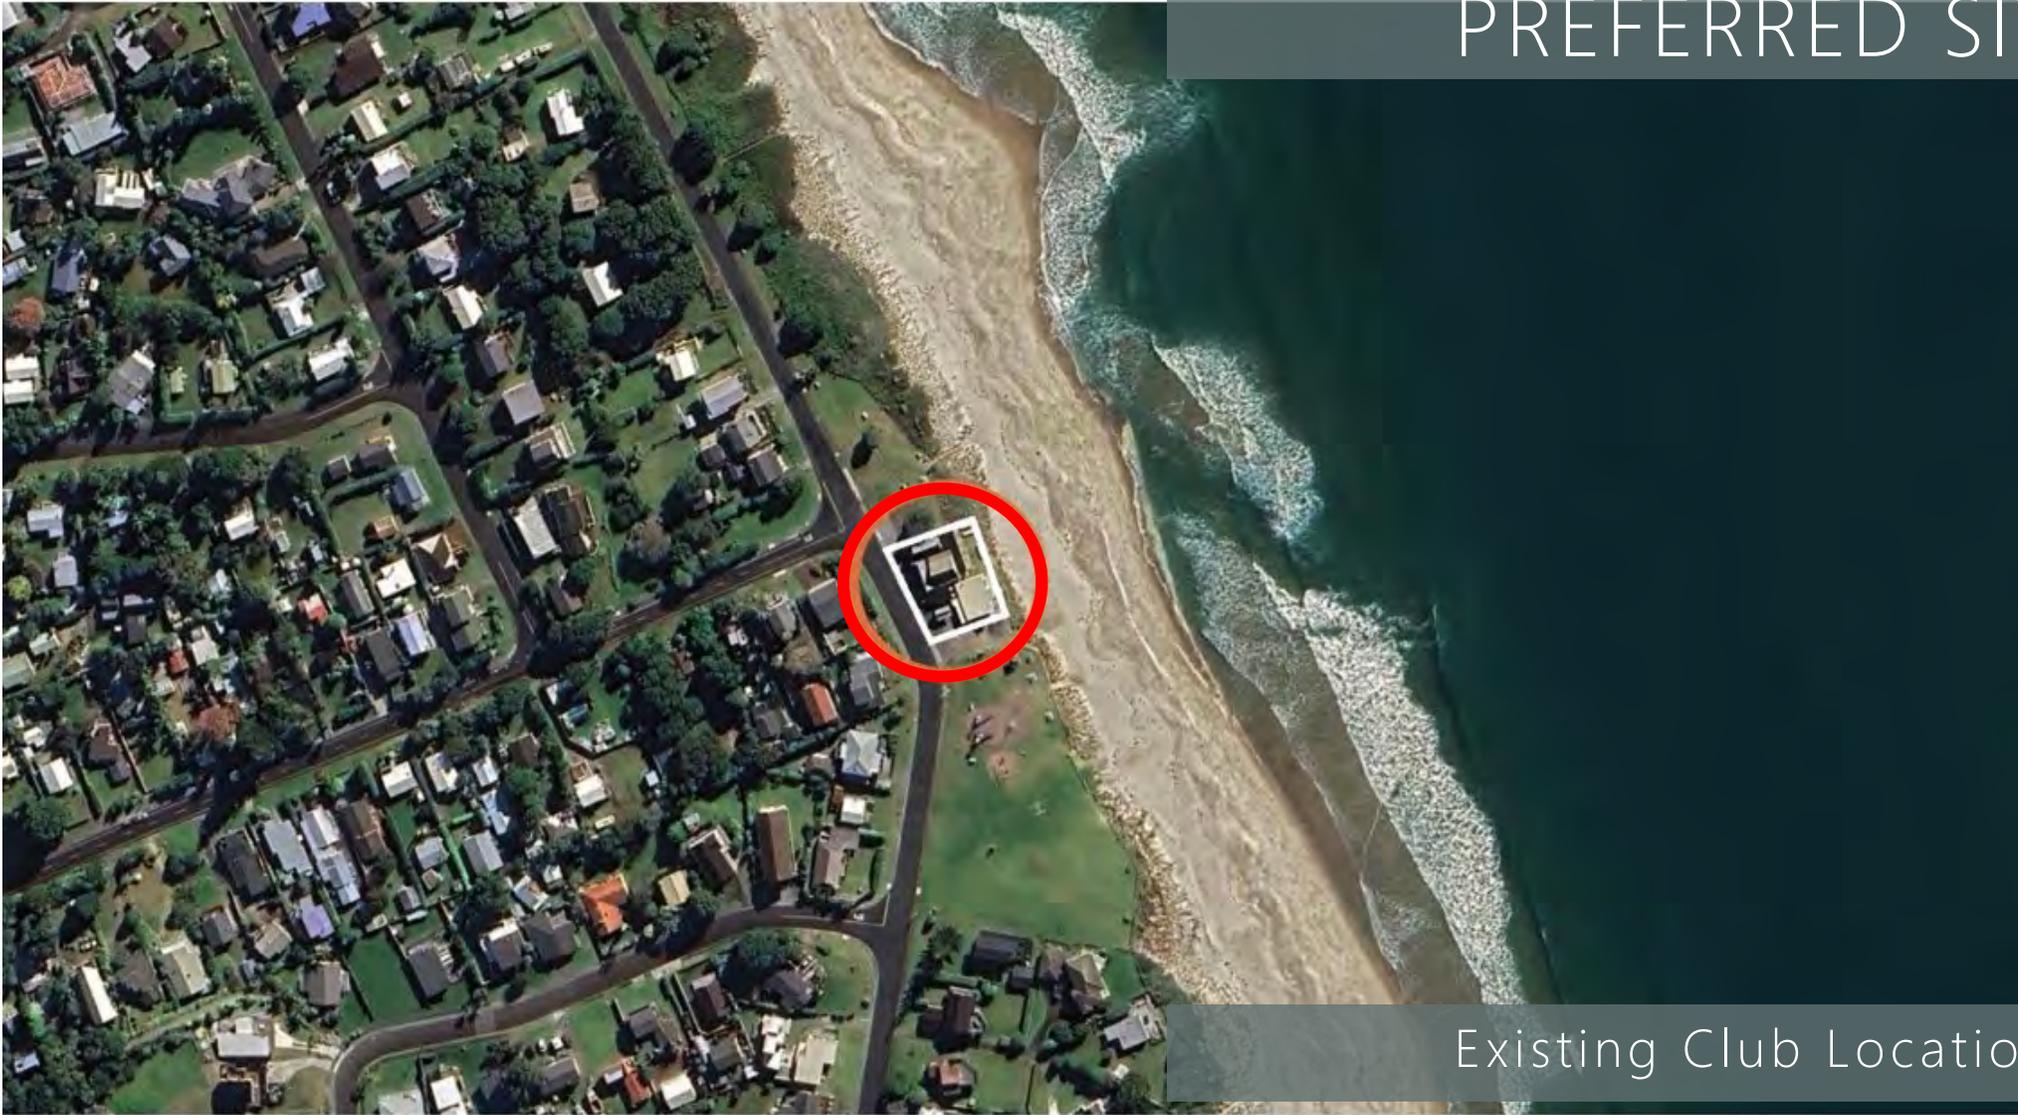
WHIRITOA SURF LIFE SAVING CLUB SITE

When considering the future erosion hazard in relation to the development proposals at the surf club, it has been identified that the relevant sea level rise scenario to be considered is +0.63m to 2090, according to the latest national guidance (MfE, 2022). If we were to adopt the same parameters for the subject site as above, an approximate shoreline retreat of 15m can be interpolated for 0.63m rise in sea level over the next approximately 67 years (to 2090). This should be added to the 13.5m immediate erosion hazard calculated above, to provide a combined future erosion distance of 28.5m from the present day dune toe. This does not take into account any beach management activities, such as local nourishment which is proposed.

Overall, it is concluded that the proposed surf club development will not accelerate, worsen or result in further damage to the subject site and any existing land or structures/buildings caused either directly or indirectly by coastal erosion or inundation.

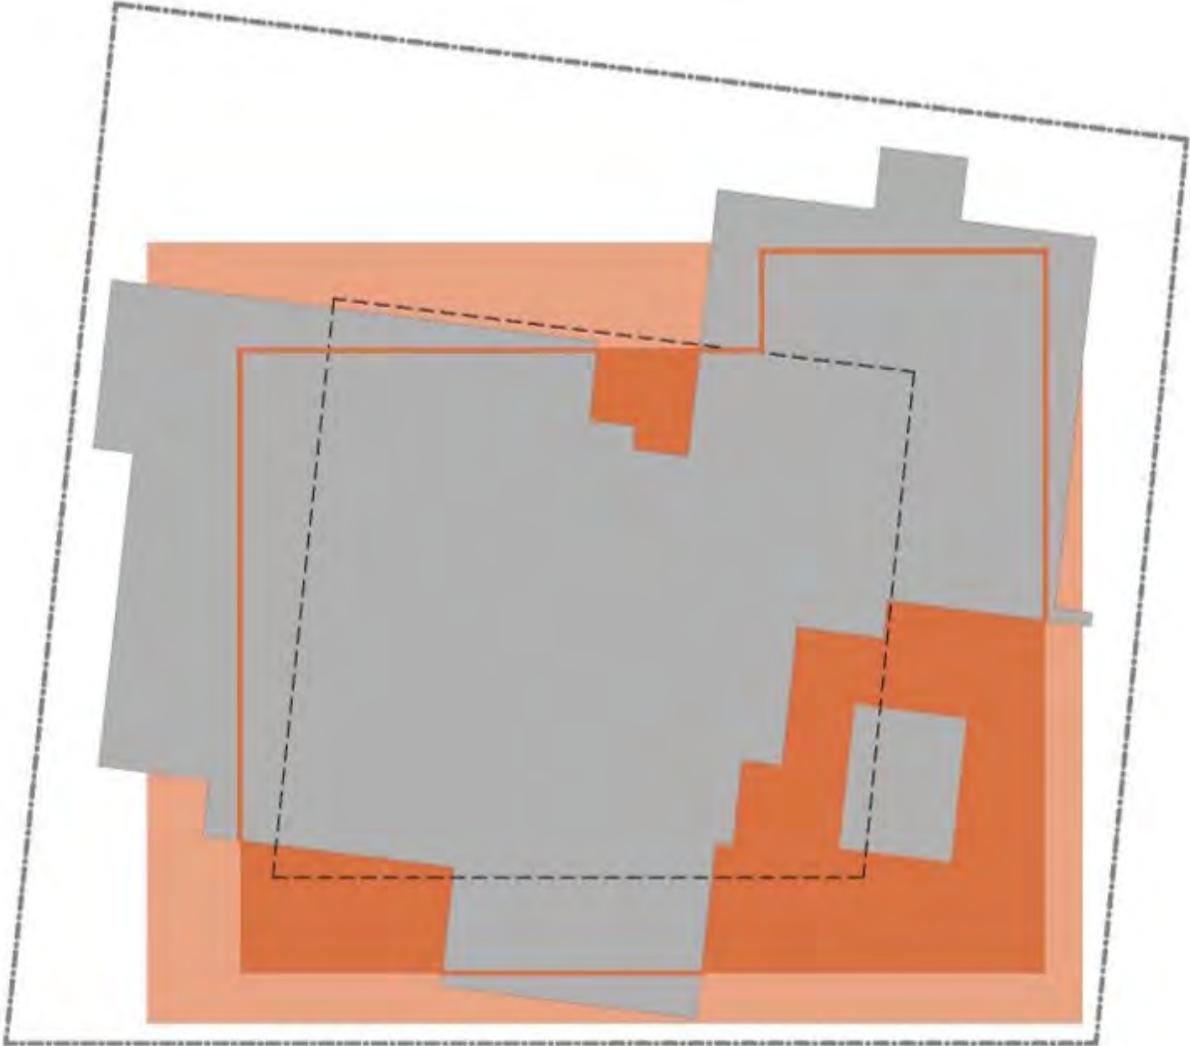
- YARD SETBACKS
- EXISTING BUILDING EXTENTS
- PROPOSED BUILDING FORM
- PROPOSED BUILDING INTERNAL FOOTPRINT
- EXISTING BUILDING FOOTPRINT

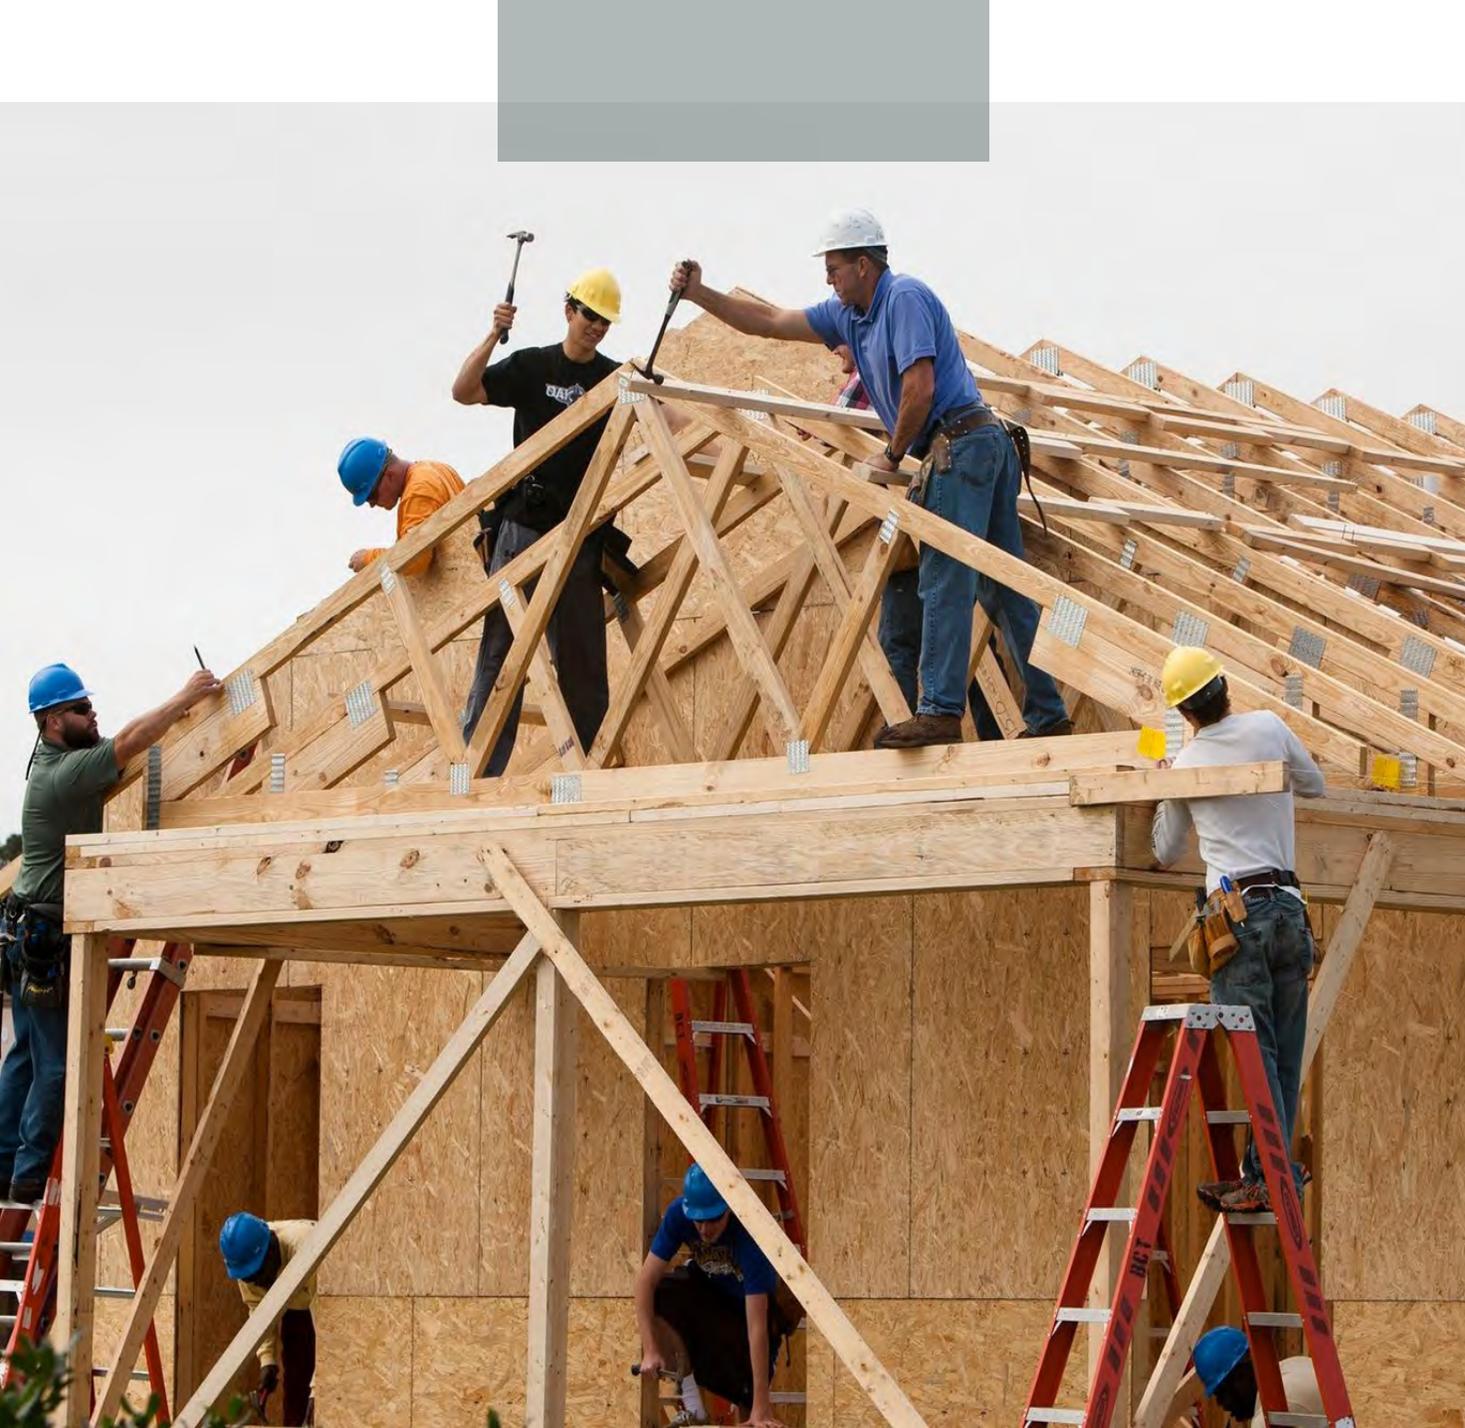
TRADITIONAL CONSTRUCTION

Trades come to site each day

All materials are delivered

Some efficiencies (pre-cut / Pre-nail)

Labour intensive

Potential for build delays on site with weather

Potential for additional construction costs for temporary works

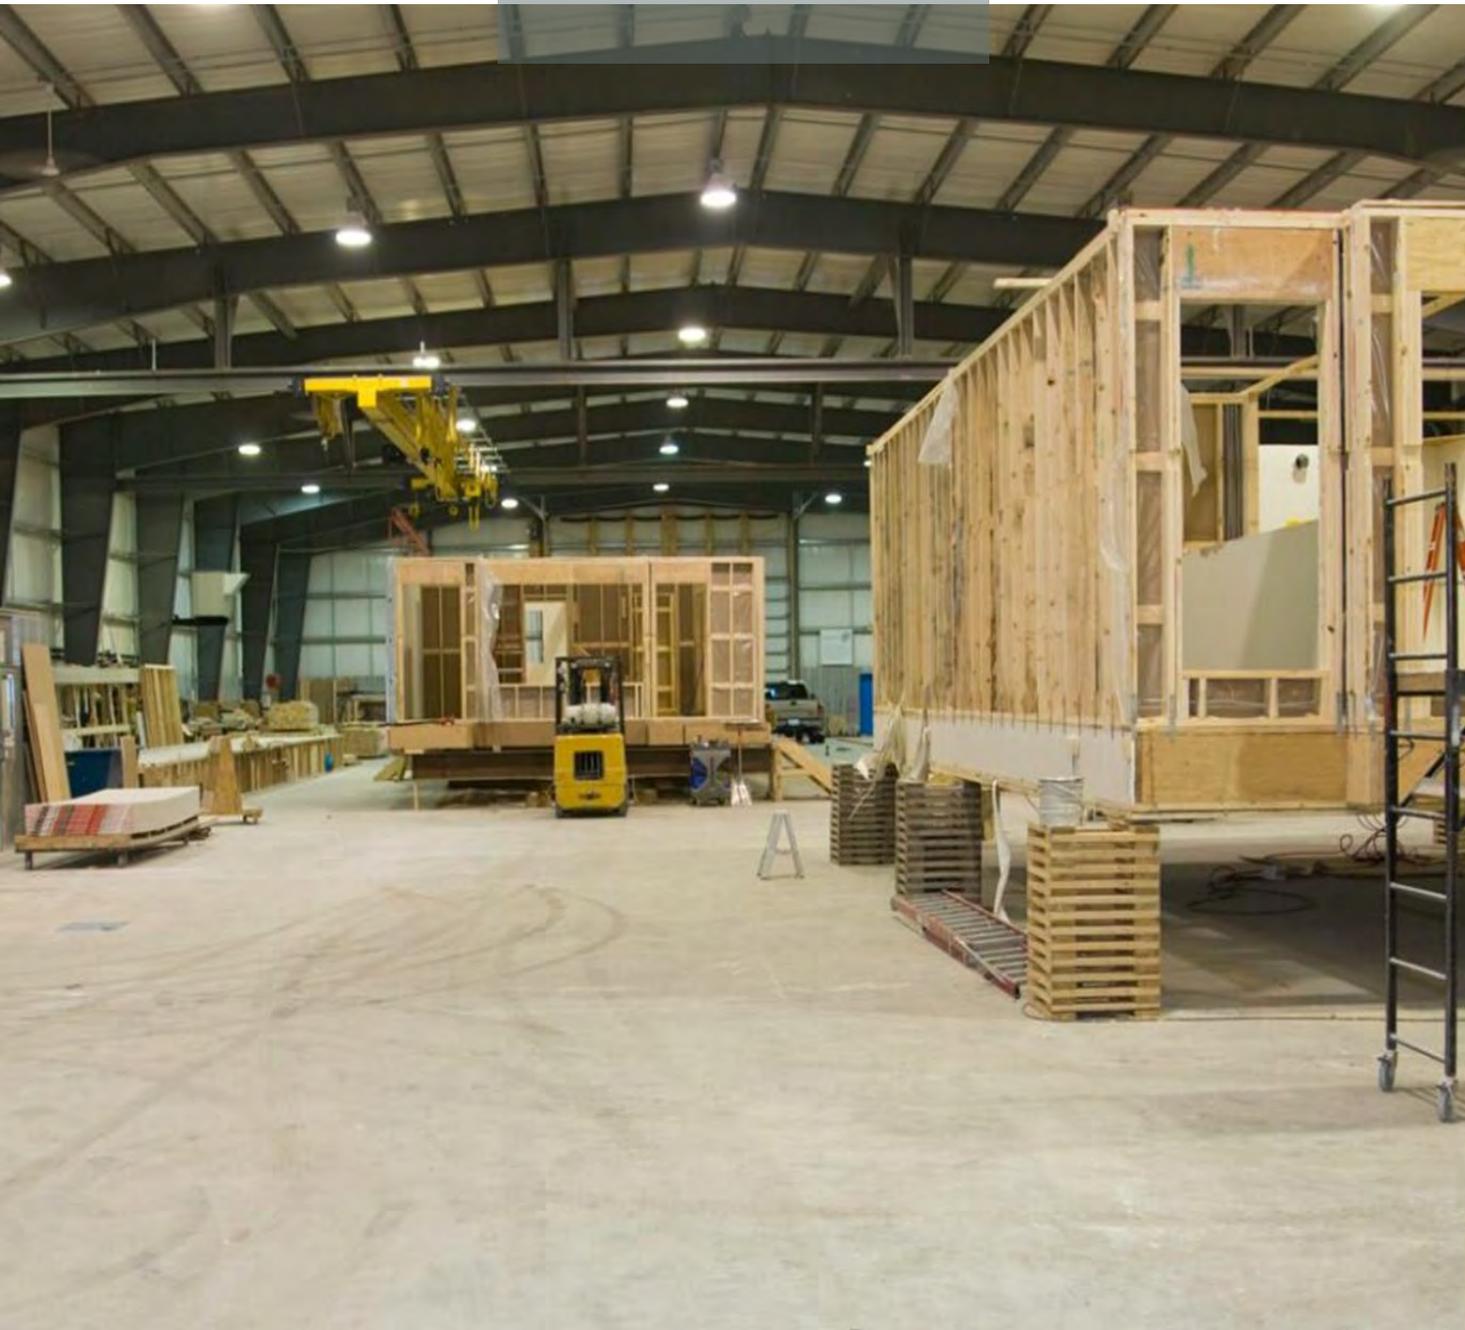
OFFSITE PREFABRICATED

Majority of the build is undertaken off-site on a controlled site

Completed modules are trucked to site and joined
Prefabricated modules can be begun much earlier than site works

More efficient use of trades as they are travelling shorter distances

Better Health and safety management

Reduced security risk on site

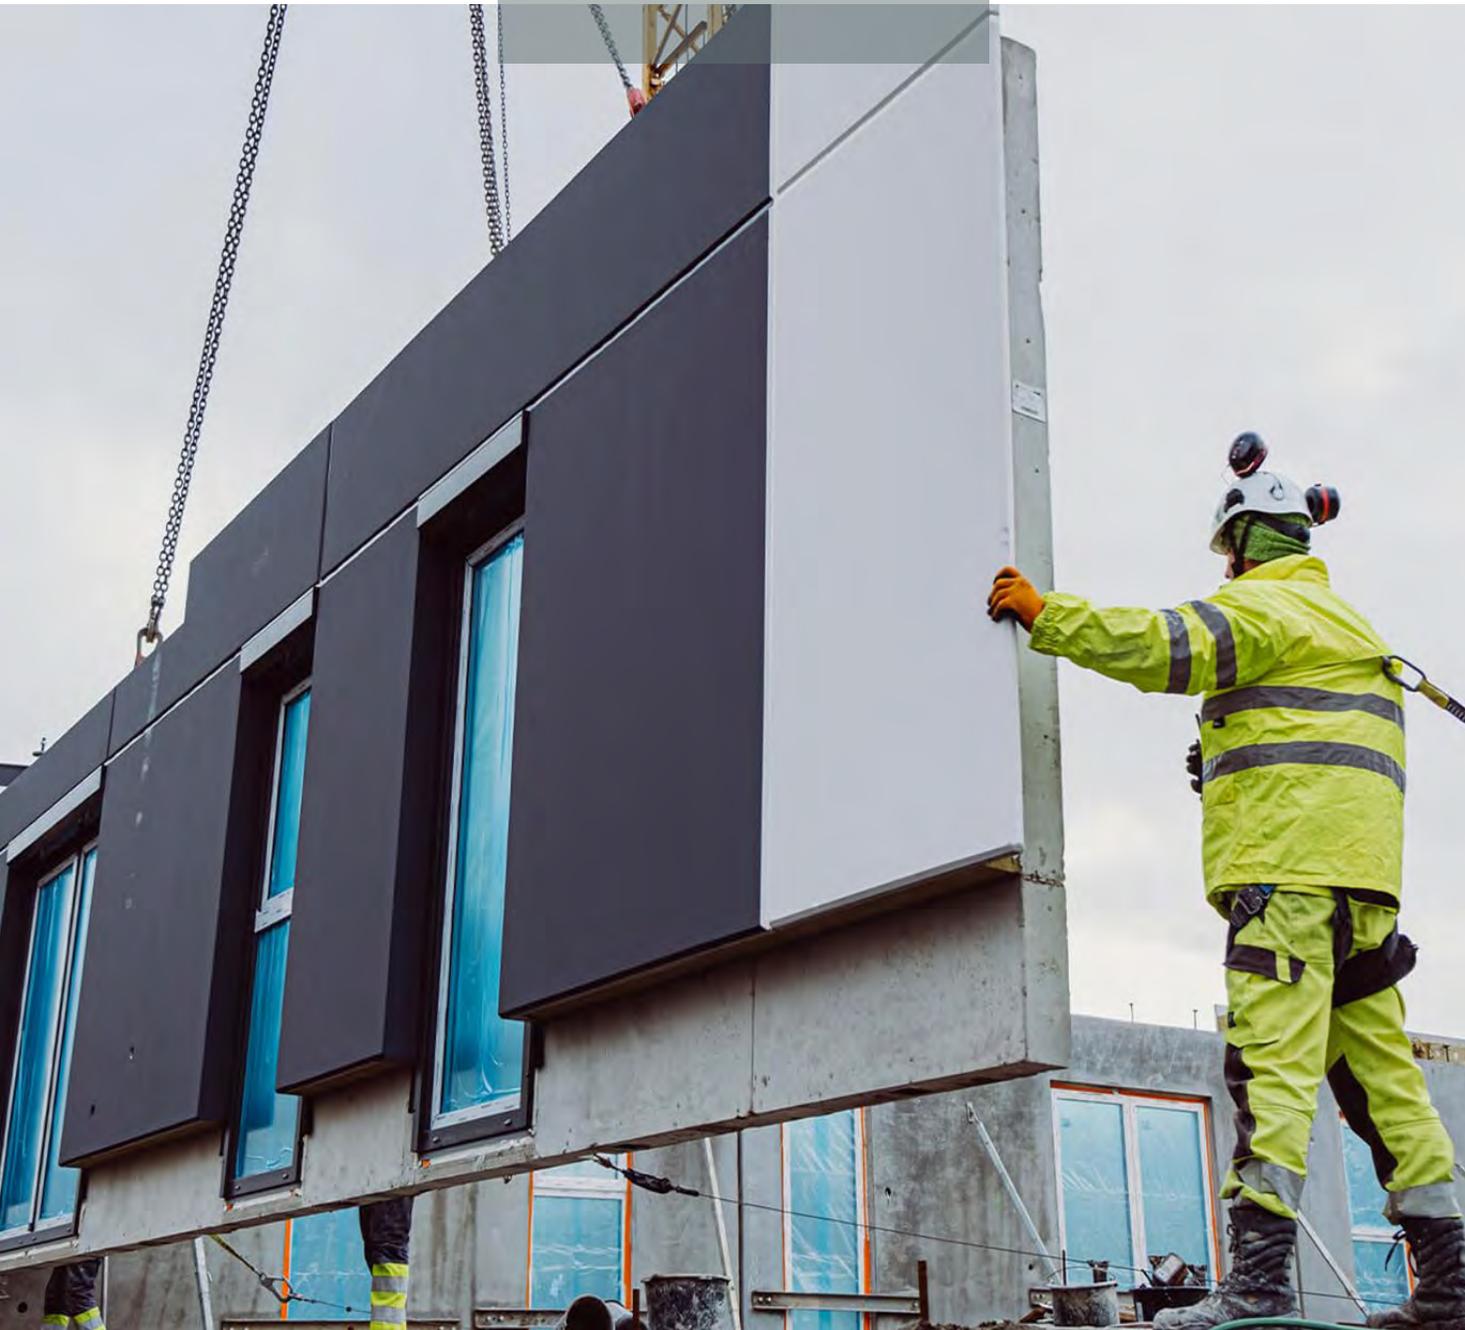
HYBRID CONSTRUCTION

The club could be deconstructed into modules and relocated (temporarily or permanently).

Asset can be saved rather than demolished... protecting our investment.
